SCS DAM PA-445

NDI NO. PA-00099

PHASE I INSPECTION REPORT.
NATIONAL DAM INSPECTION PROGRAM.

MAR 1980

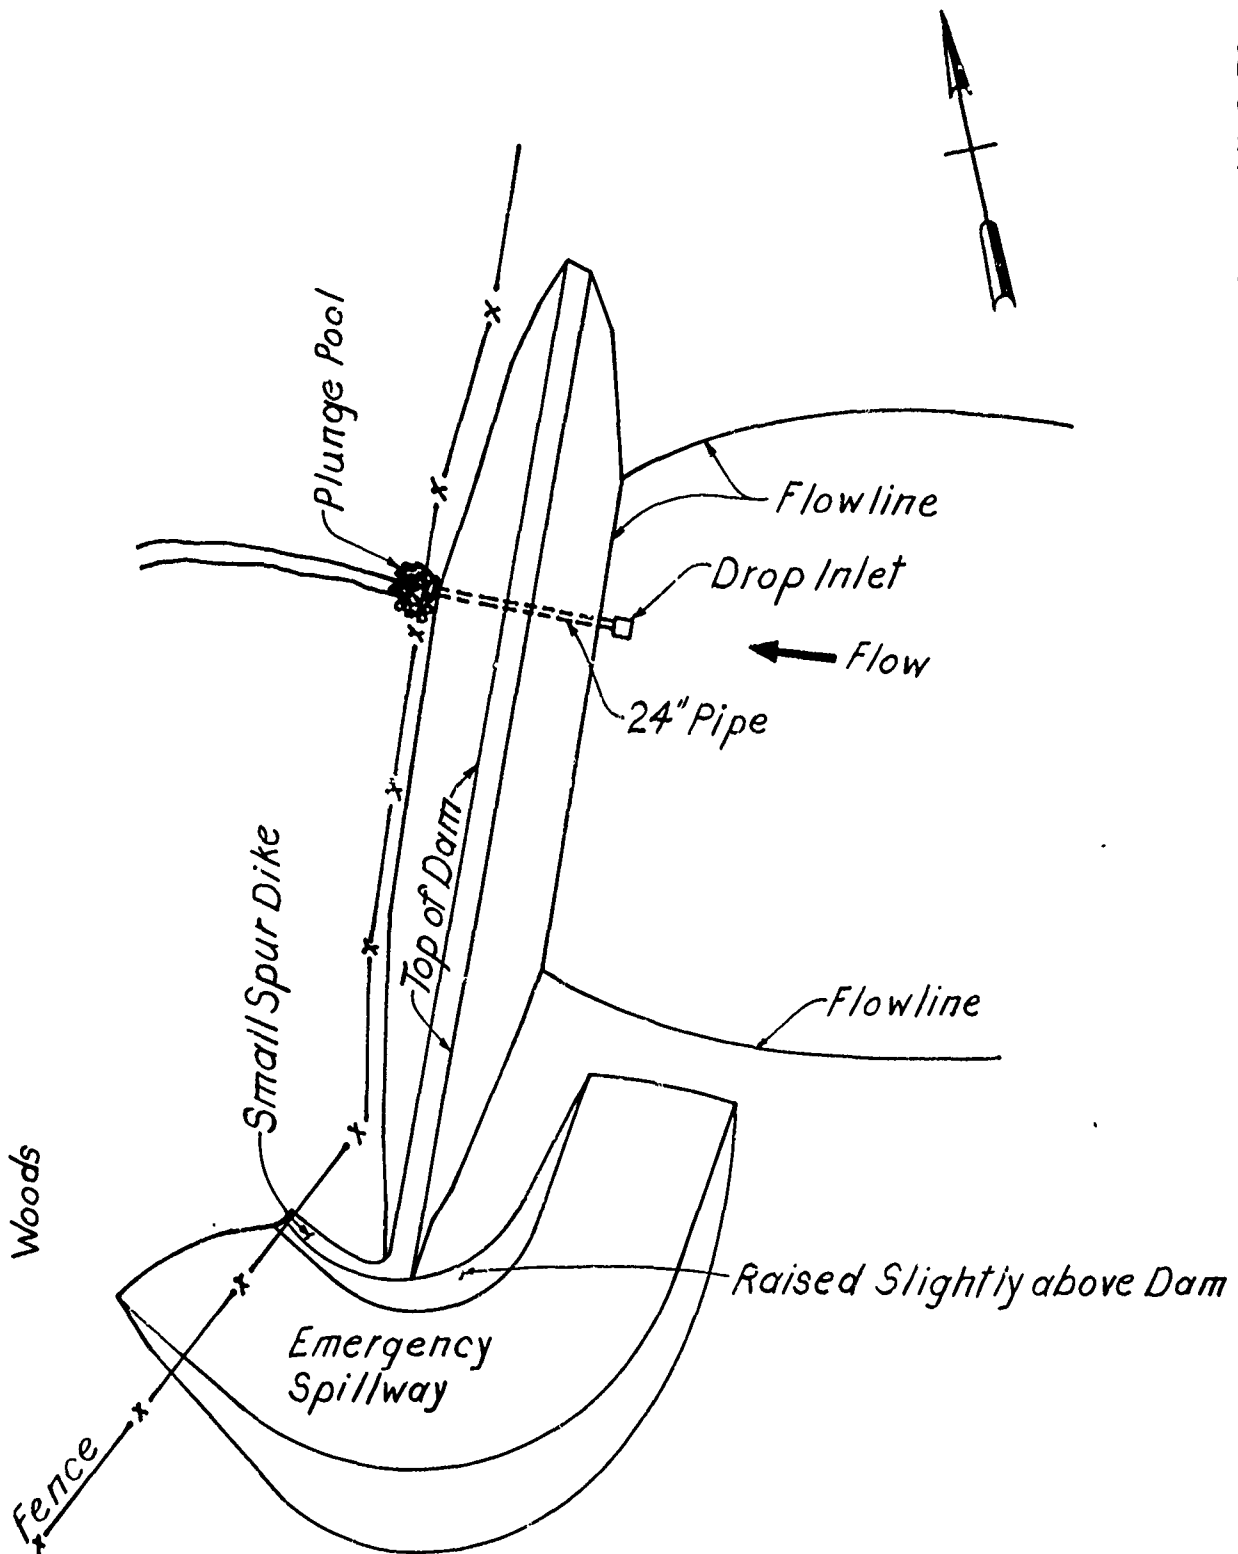
INSPECTION SURVEY
PLATE A-I

The emergency spillway in the left abutment appeared to be in good condition with a good grass mat for erosion protection. The side slopes are stable and the flow of water is directed away from the toe of the dam by a spur dike. (Appendix A, Plate A-I). The principal spillway appeared to be in good condition.

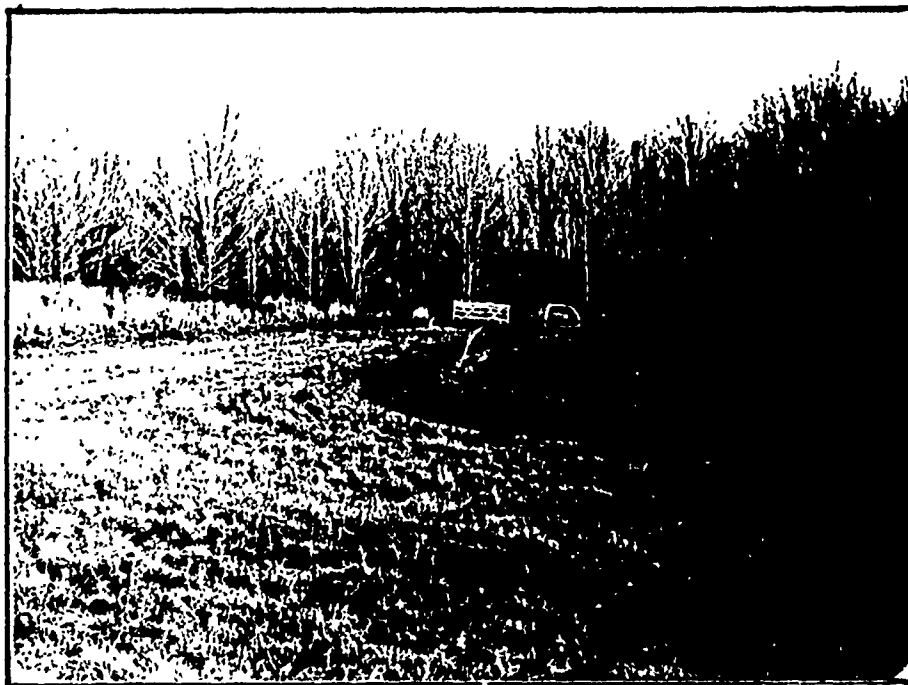
EMERGENCY SPILLWAY LOOKING DOWNSTREAM
DAM AND SPUR DIKE ON RIGHT - NO. 7
